THE USE OF ACTIVATED CARBON CLOTH (ACC) DRESSING IN MANAGING BIOFILMS: A CASE STUDY

Hazirah binti Ahmad Mokhtar, MD Wound Care Unit, Outpatient Department, Hospital Sultanah Nur Zahirah (HSNZ)

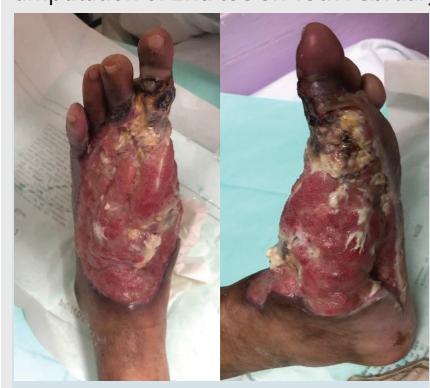
28/01/2019 (BASELINE)

Wound size measured at 15 x 19 cm, there was thick biofilm covering the wound with extensive slough over at the base of 2nd toe till mid foot.

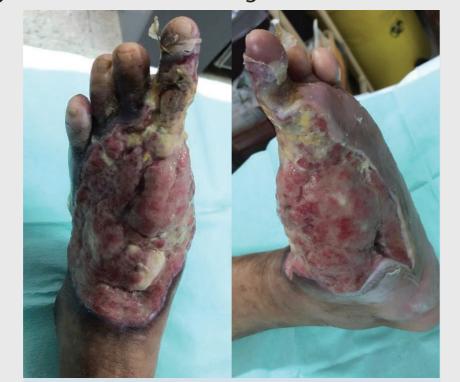
04/02/2019 (DAY 7)

There was reduction in wound size (13 cm x 11 cm), and emerging of granulation tissue (10%) with reduction in slough formation. There was thick biofilm covering the wound at base of 2nd toe. There was advancing of epithelization tissue.

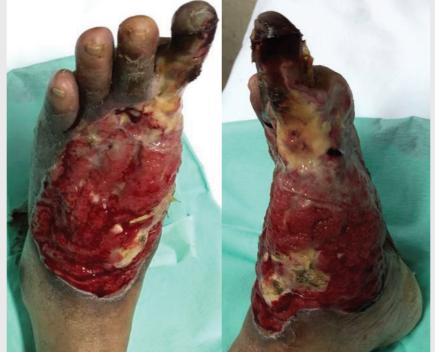
11/02/2019 (DAY 14)

There was further reduction in size of wound (11 cm x 9 cm), with remarkable amount of granulation tissue (> 50%), biofilm was minimal with advancing epithelisation. However, due to Gangrenous of left 2nd toe, patient was referred to Orthopaedic team and underwent Ray amputation of left 2nd toe.

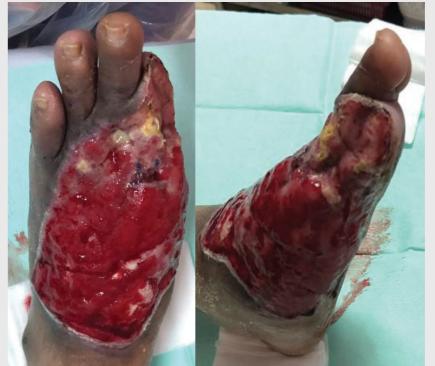
21/02/2019 (DAY 21)

Post ray amputation Left 2nd toe. There was marked improvement of wound in terms of reduction in wound size (9x9 cm), healthy granulation tissue with no sign of infection.

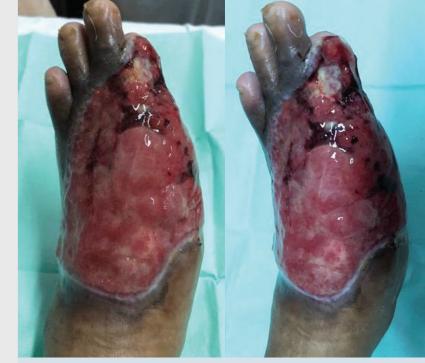
03/03/2019 (DAY 31)

Wound Size 6cm x 5 cm, healthy granulation tissue seen with absence of infection, good moisture balance with advancing epithelization. Patient was planned for split skin graft (SSG).
